Assessment of Dam Safety

Coal Combustion Surface Impoundments (Task 3)

PacifiCorp

Naughton Power Station

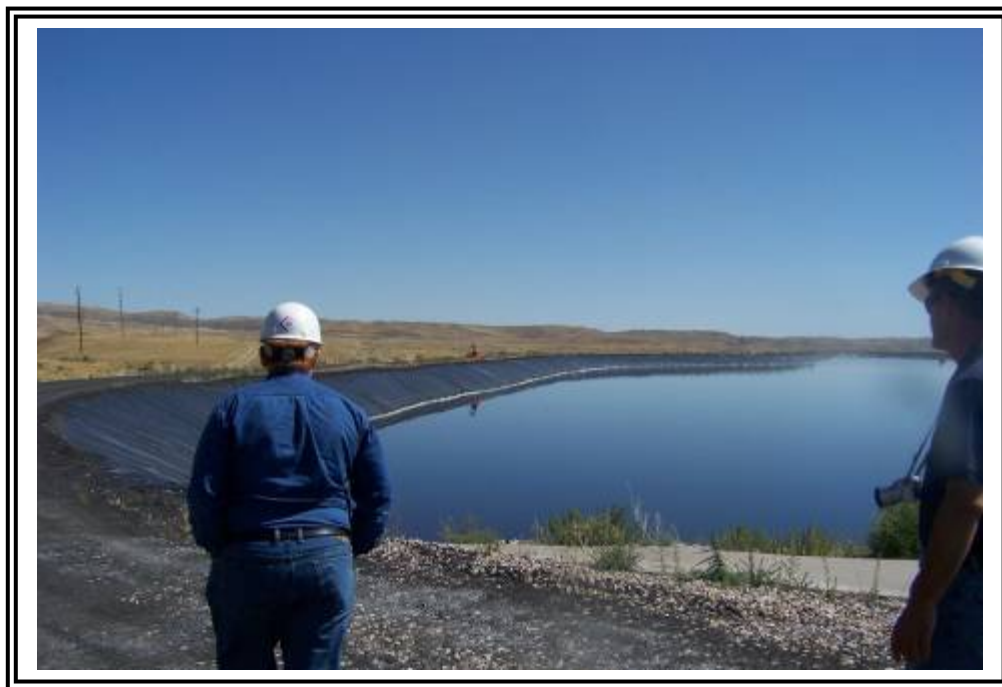
1

The upstream slope is covered with a 30 mil PVC liner as shown in Photos 1, and 18. A couple of depressions were noted on the upstream slope/crest intersection at the north end of the northeast dike as shown in Photo 3. PacifiCorp representatives indicated this was an area where sluice lines had formerly been laid, and that some frost heaving issues had occurred. The access road on the crest was re-graded, but the resulting depressions at the top of the upstream slope were not repaired.

Upstream slope of northeast dike looking east.

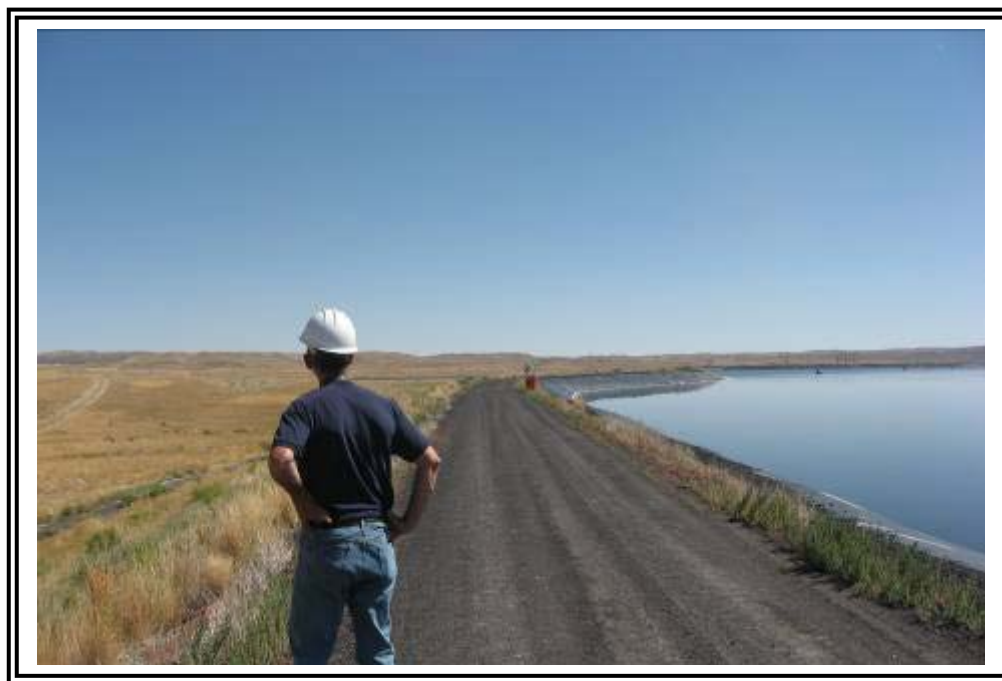
2

In general the alignment of the encircling dike crest appears to match the design drawings reviewed for this project. There is an access road that runs the entire length of the dike crest. In some areas, re-grading of this access road has led to over steepening of the top of the downstream slope as shown in Photo 4. Photos 2, 15, 20, and 25 show the general conditions of the crest around the FGD #1 Pond.

Crest of northeast dike looking southeast.

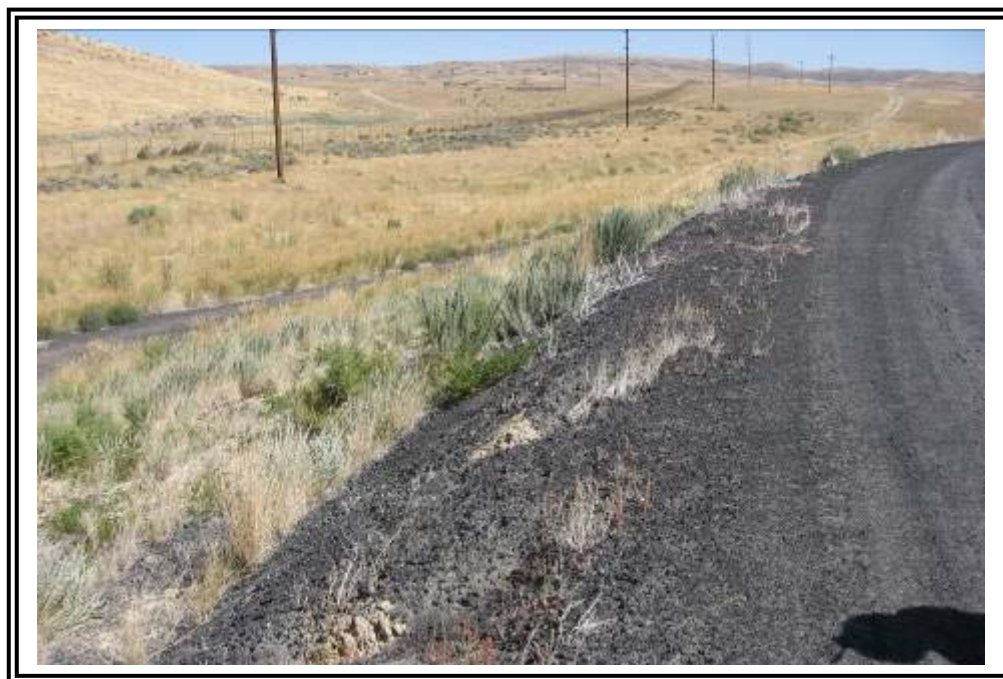
4

Over steepening of downstream slope at crest of northeast dike from across road grading.

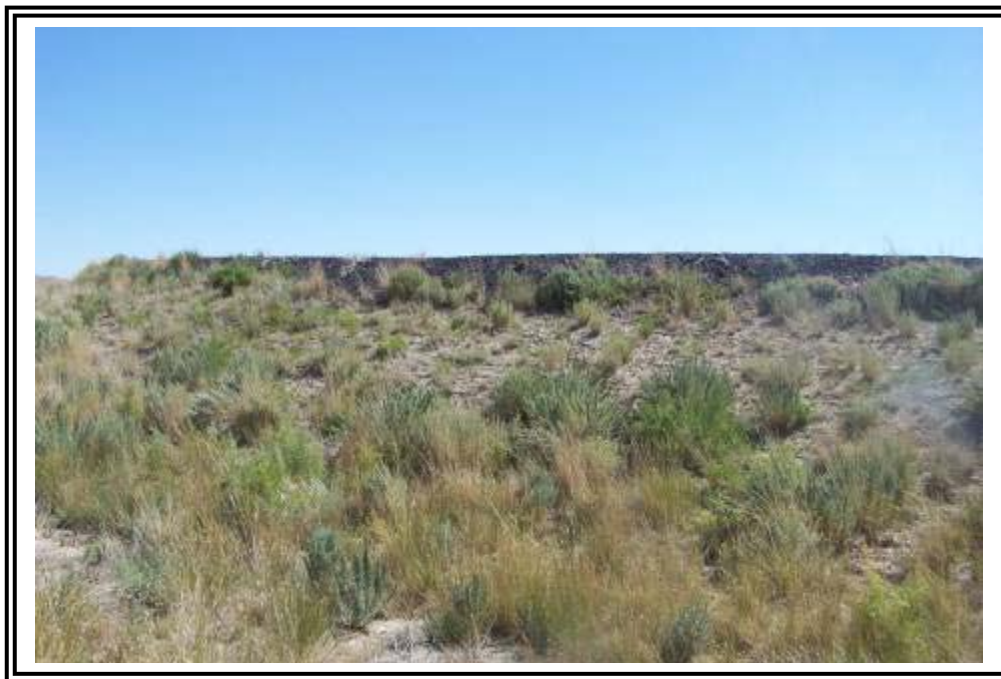
6

The downstream slope is vegetated primarily with crested wheatgrass. Photos 6, 8, 17, and 29 show the general conditions of the vegetation. As these photos show, the vegetation is very sparse in some areas, with apparent growth hampered by prevailing direction the slopes face. Occasional erosion rills were noted, such as that shown in Photo 5. A series of animal burrows were observed near the north end of the northeast dike as shown in Photo 9. In general the slopes appear fairly uniform, and did not exhibit signs of movement.

Typical vegetation cover on north end of FGD #1 Pond downstream slopes.

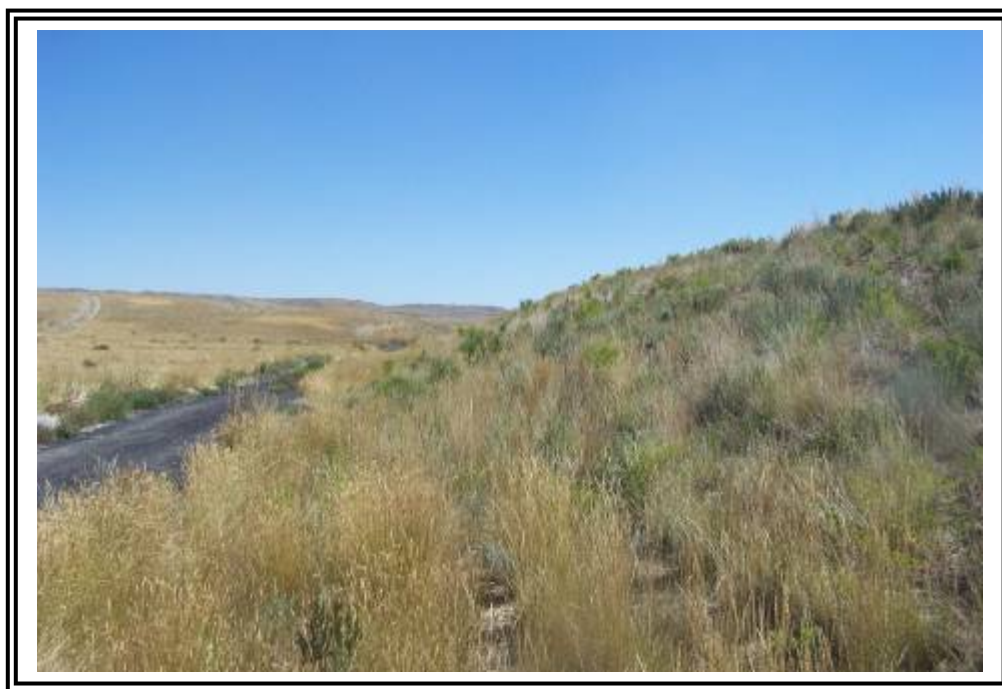
7

Downstream slope at north end of northeast dike.

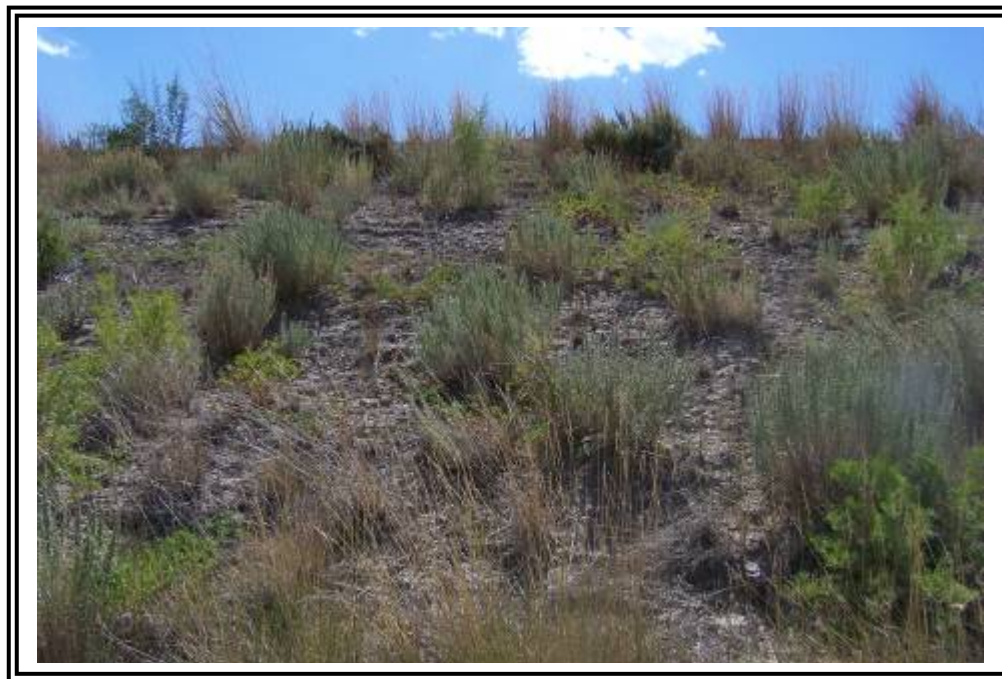
8

Sparse vegetation cover on northeast dike downstream slope.

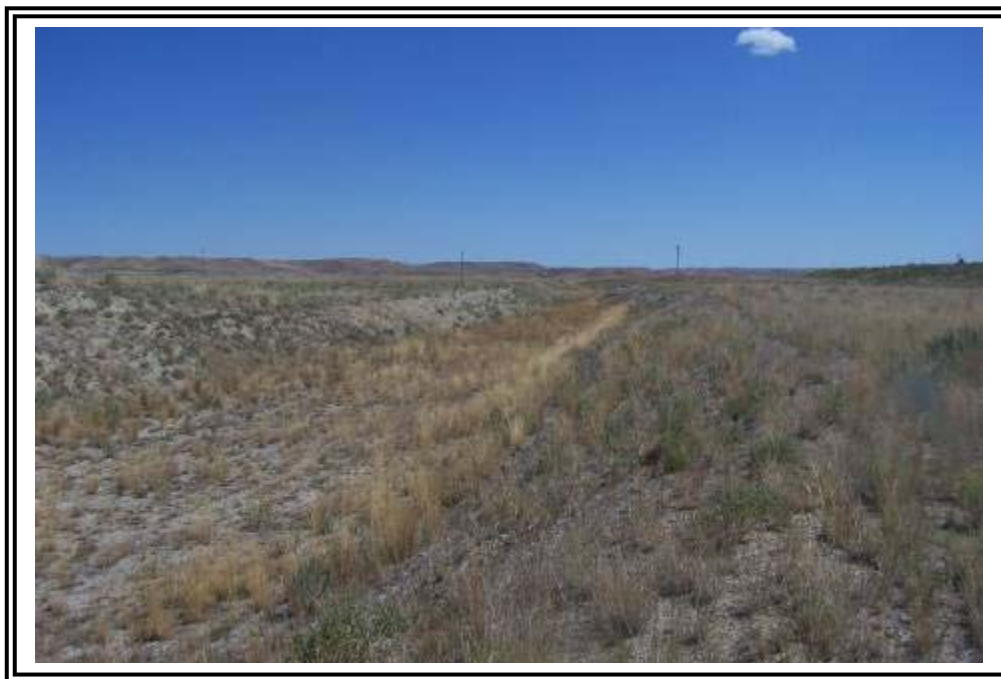
12

Diversion channel along northeast side of FGD #1 Pond toe.

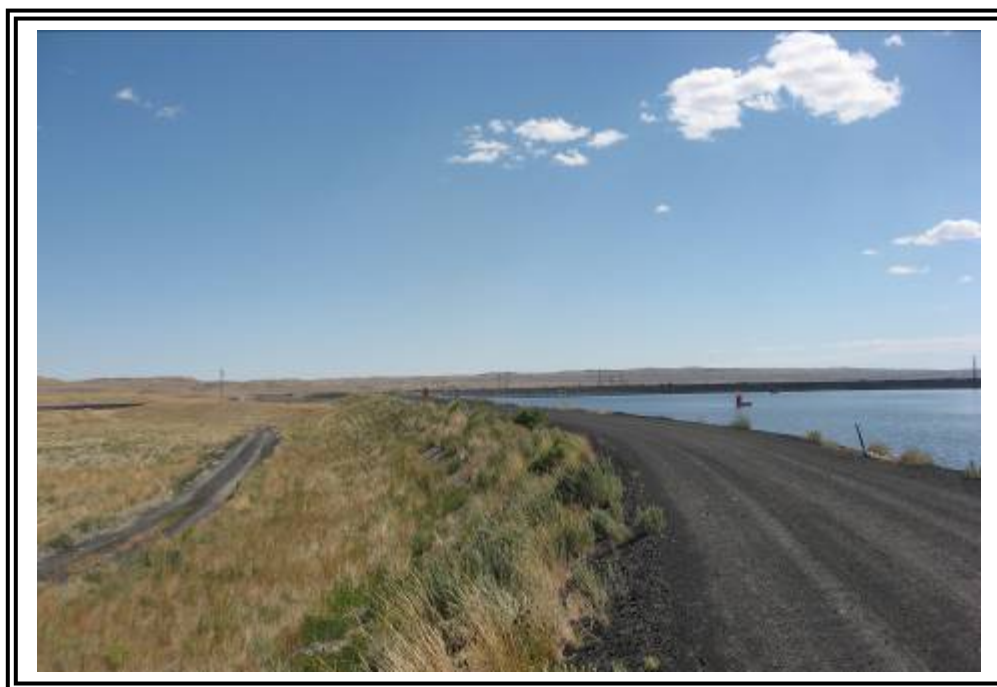
13

Downstream edge of south end of northeast dike.

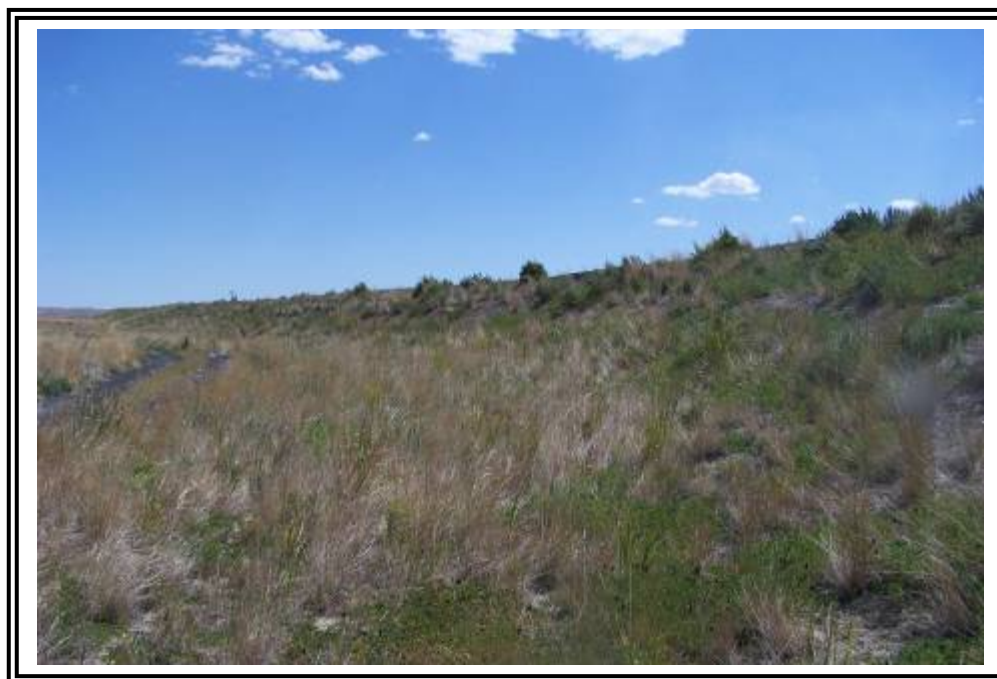
14

Toe of mid section of northeast dike.

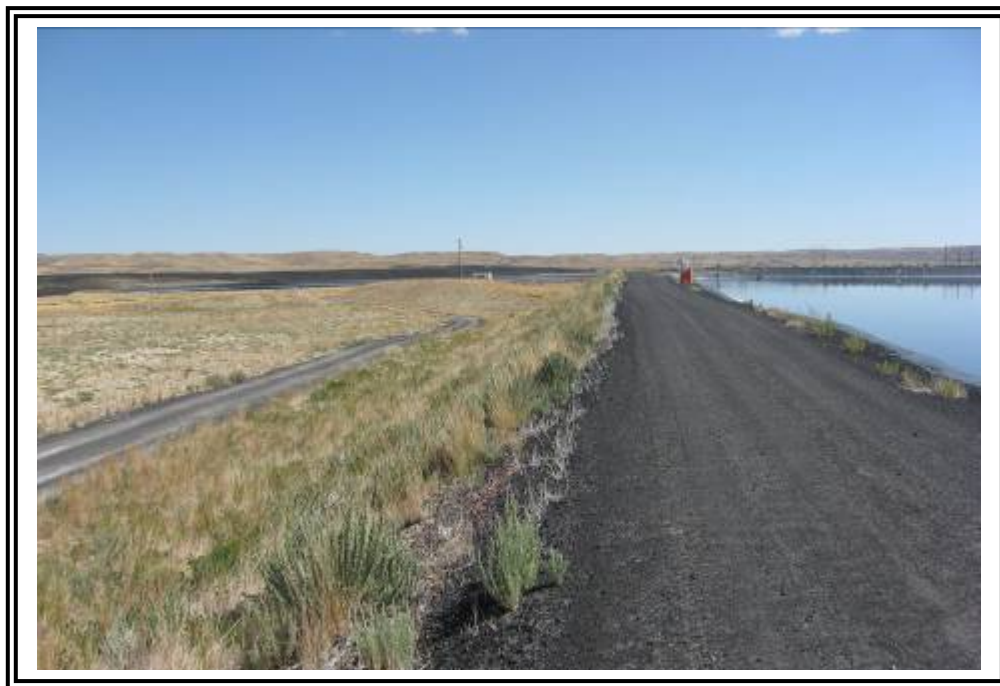
15

Crest of south end of northeast dike.

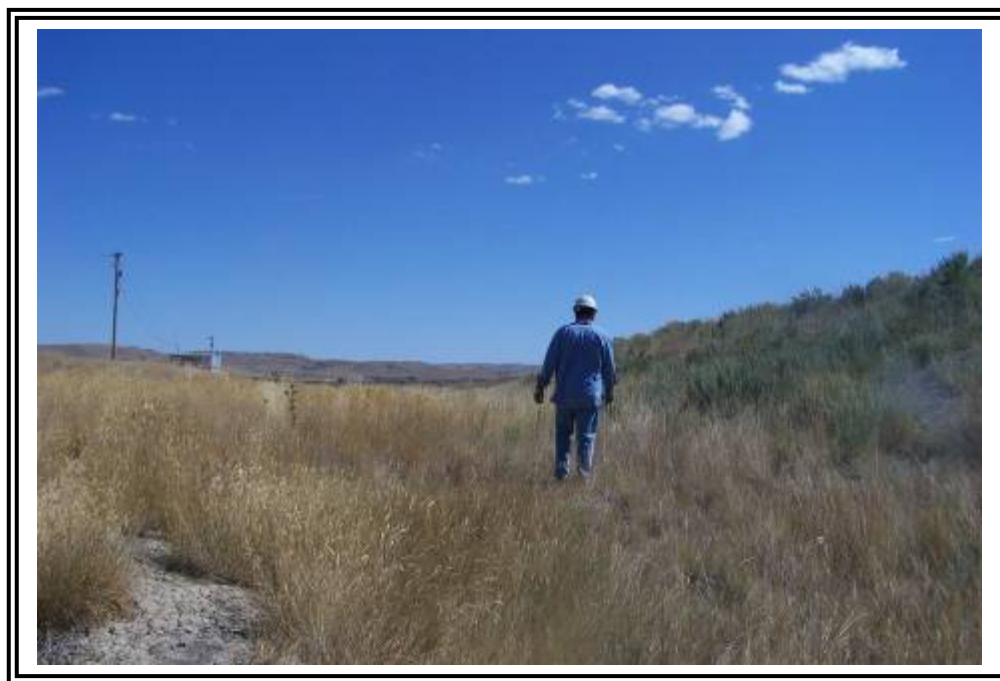
16

Toe of south end of northeast dike.

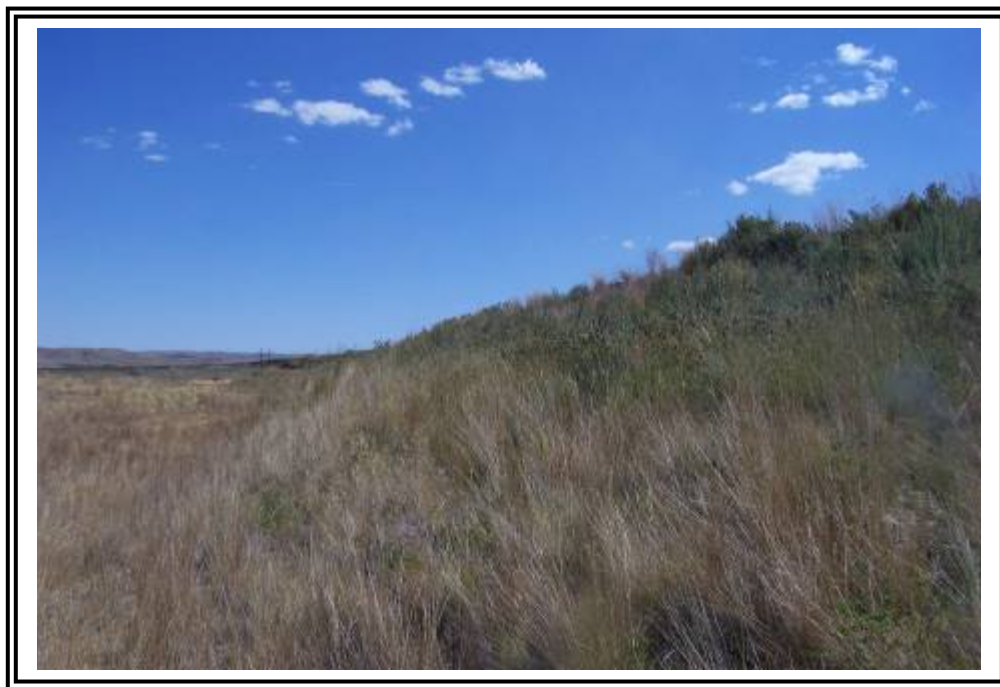
17

Typical vegetation at south end of northeast dike.

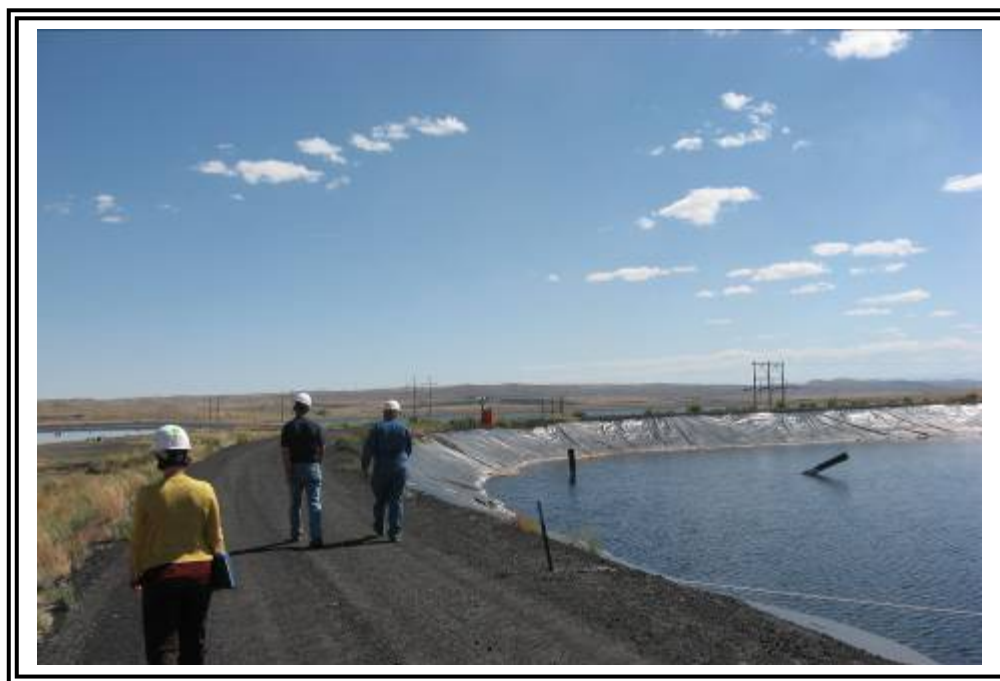
18

Upstream slope of southeast dike looking south.

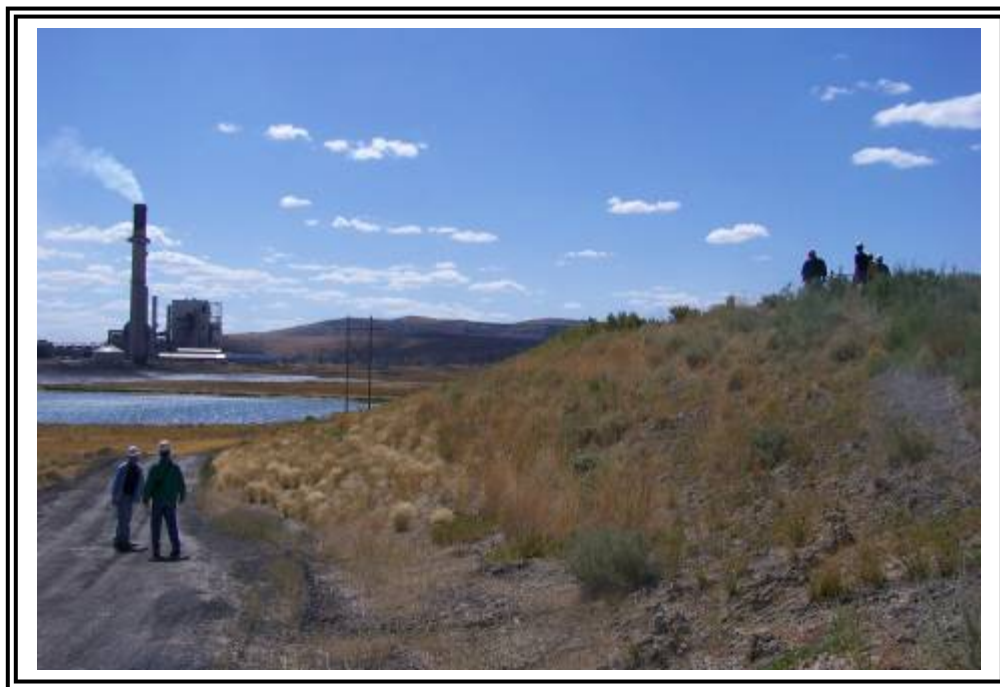
19

Downstream slope of southeast dike.

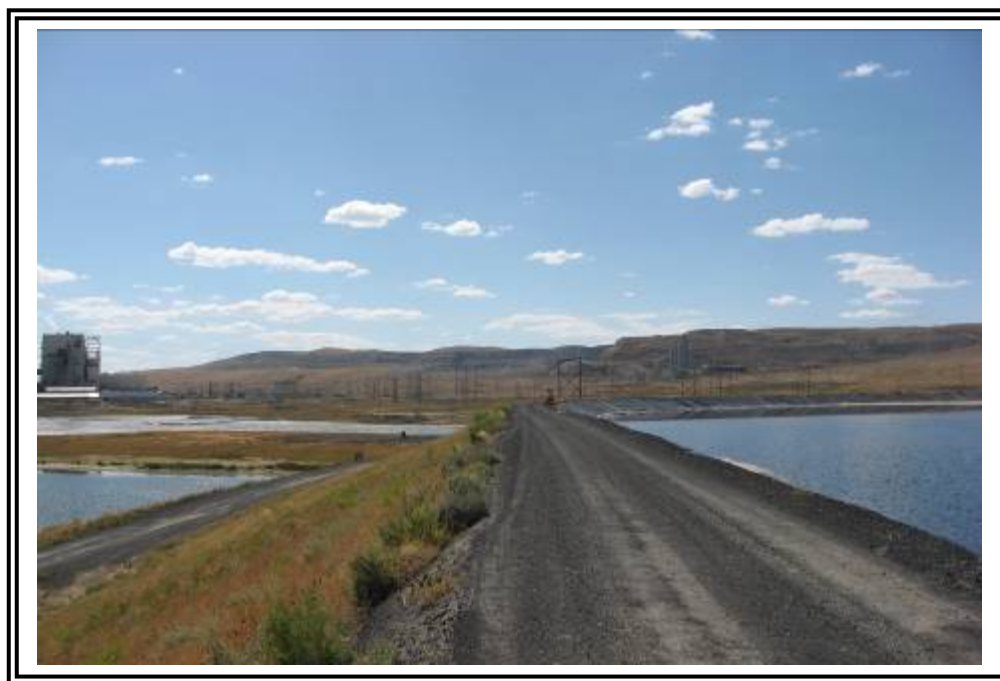
20

Crest of southeast dike.

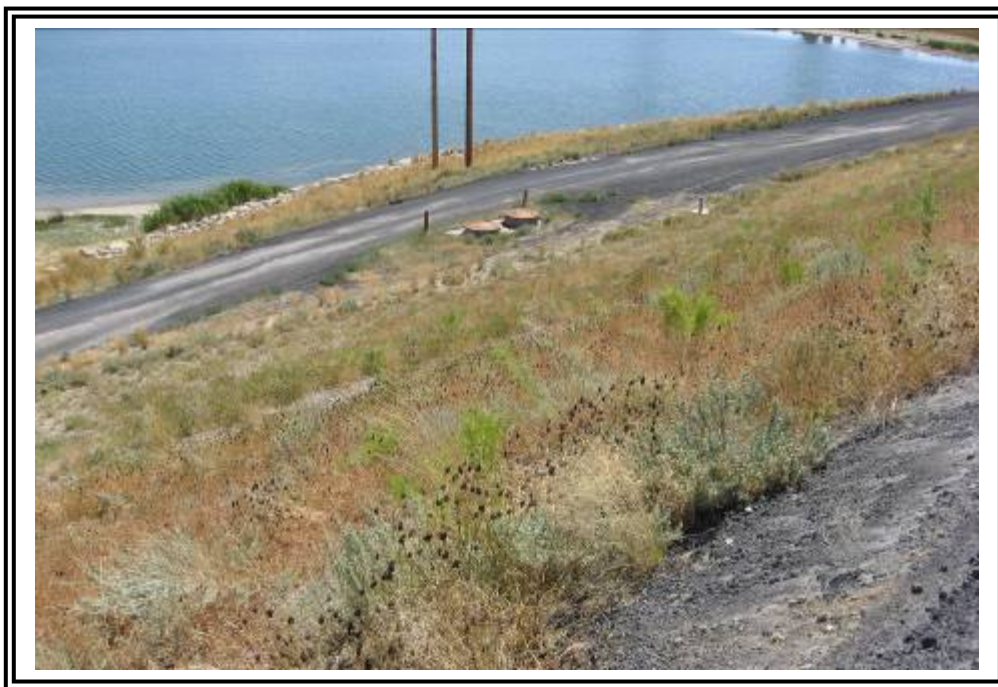
21

Valve at toe of southeast dike (contains cleanouts to sluice line to FGD #2 Pond).

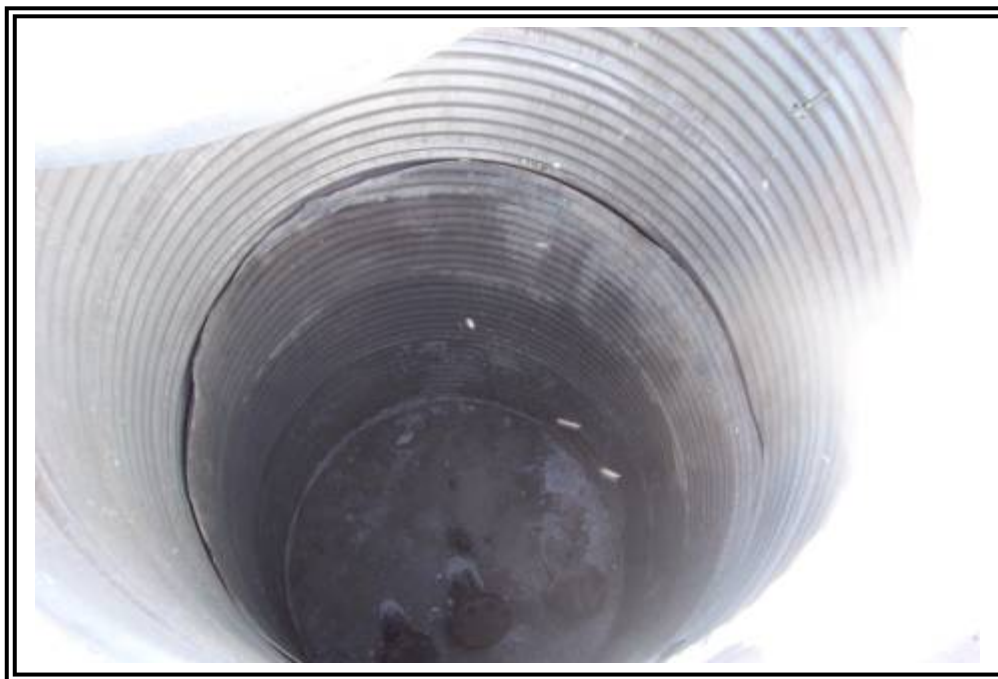
22

Valves in vault at toe of southeast dike about 13 feet deep (cleanouts to sluice line to FGD #2 Pond).

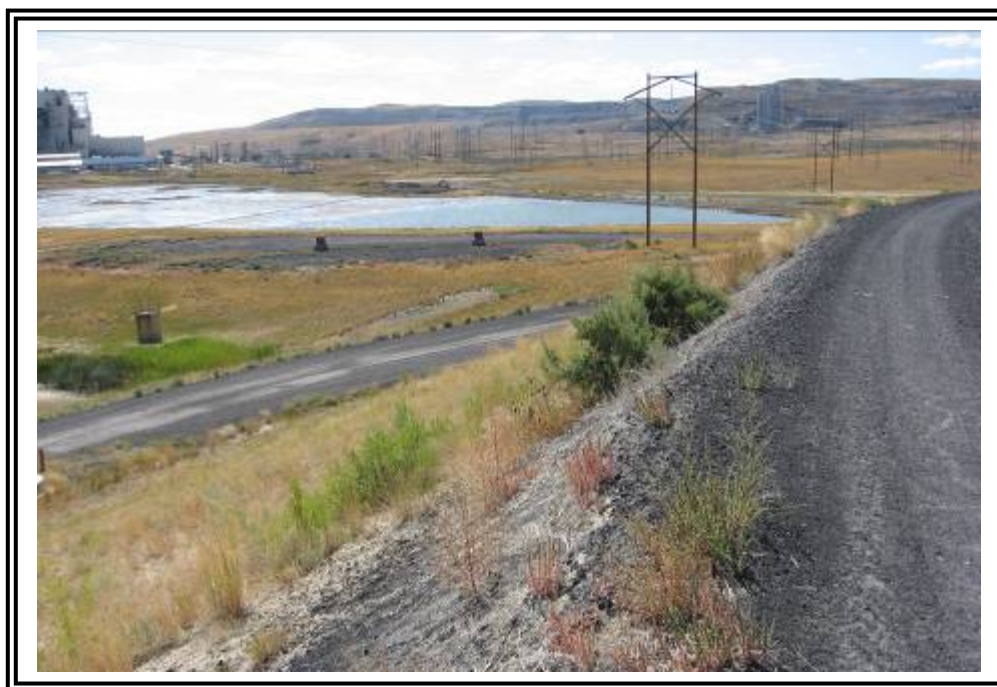
23

Upstream slope south end of southeast dike.

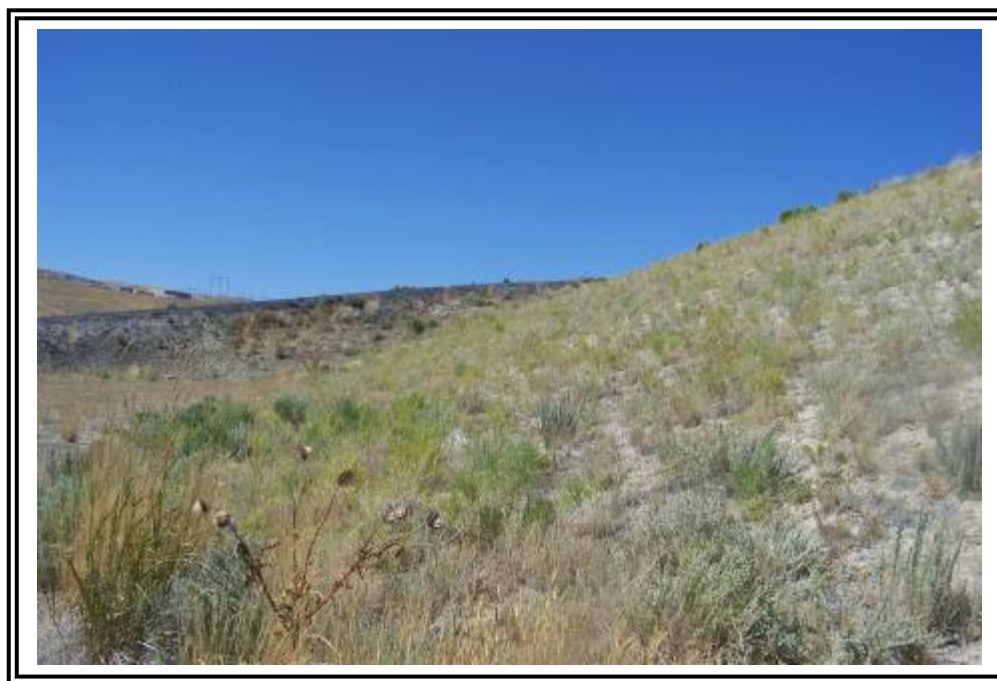
24

Downstream slope at south end of the southwest dike and ramp for access road to crest.

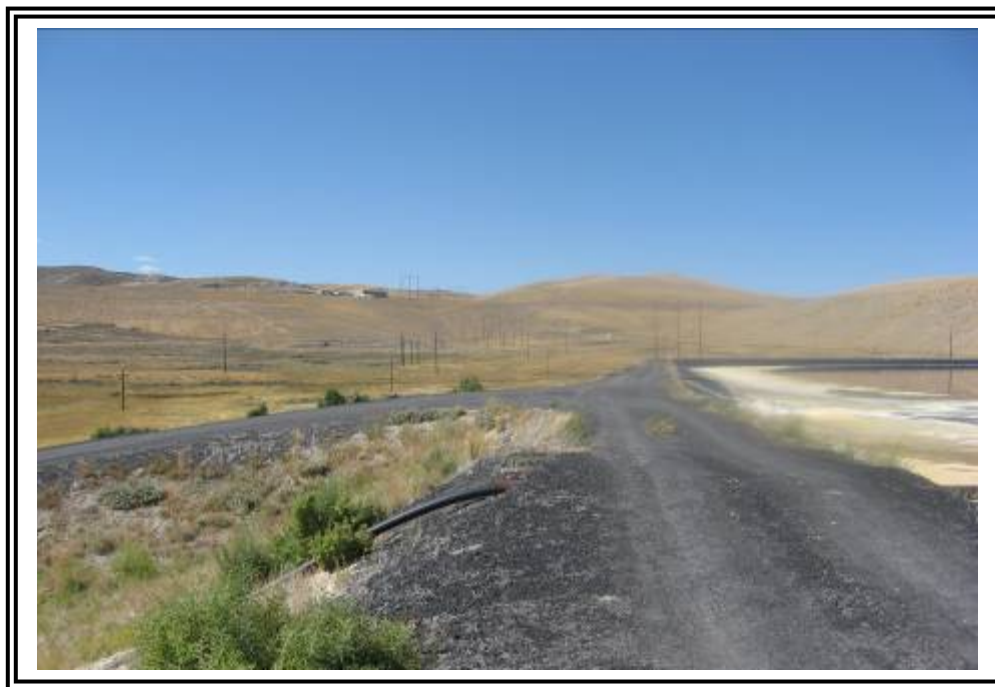
25

Crest of southwest dike looking northwest. Sluice line in foreground.

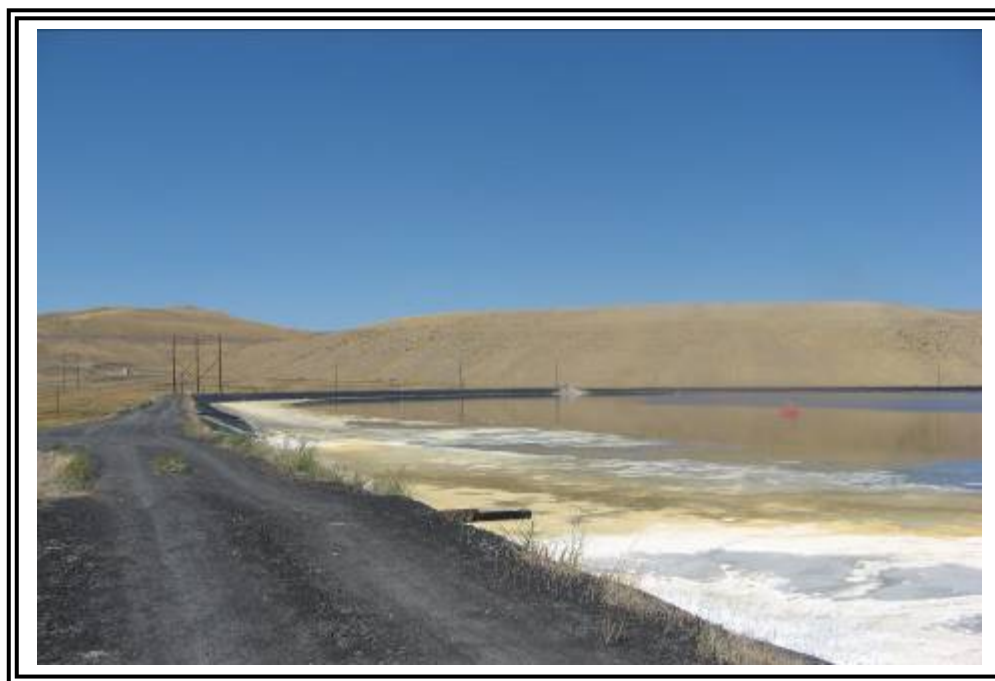
26

Sluice discharge area along southwest dike.

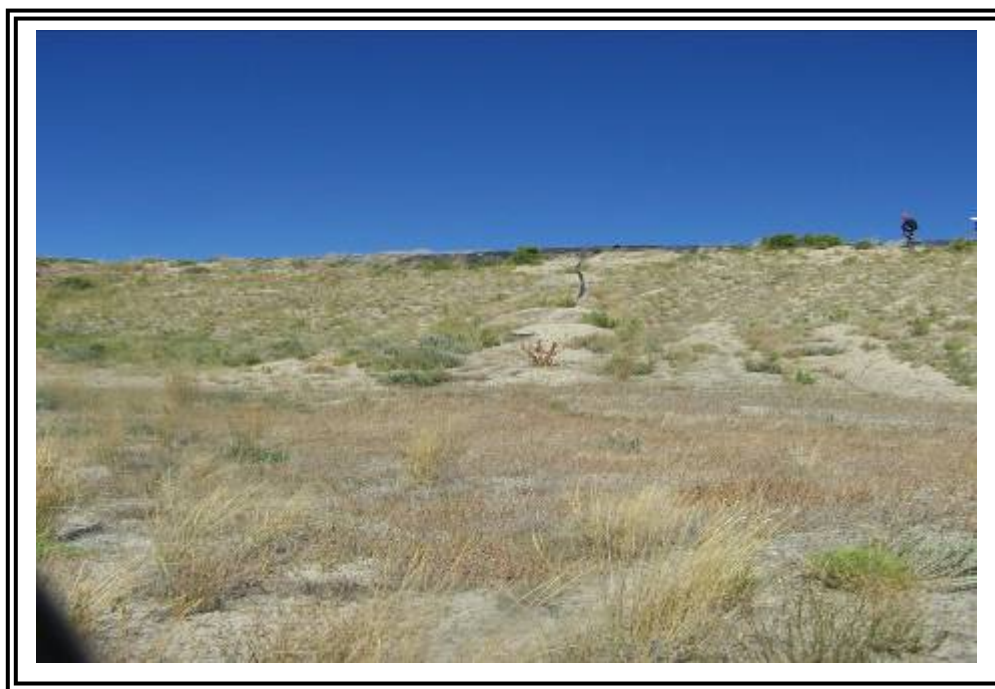
27

Sluice line at ground surface up downstream slope of southwest dike. Soil piles "anchor" HDPE pipe.

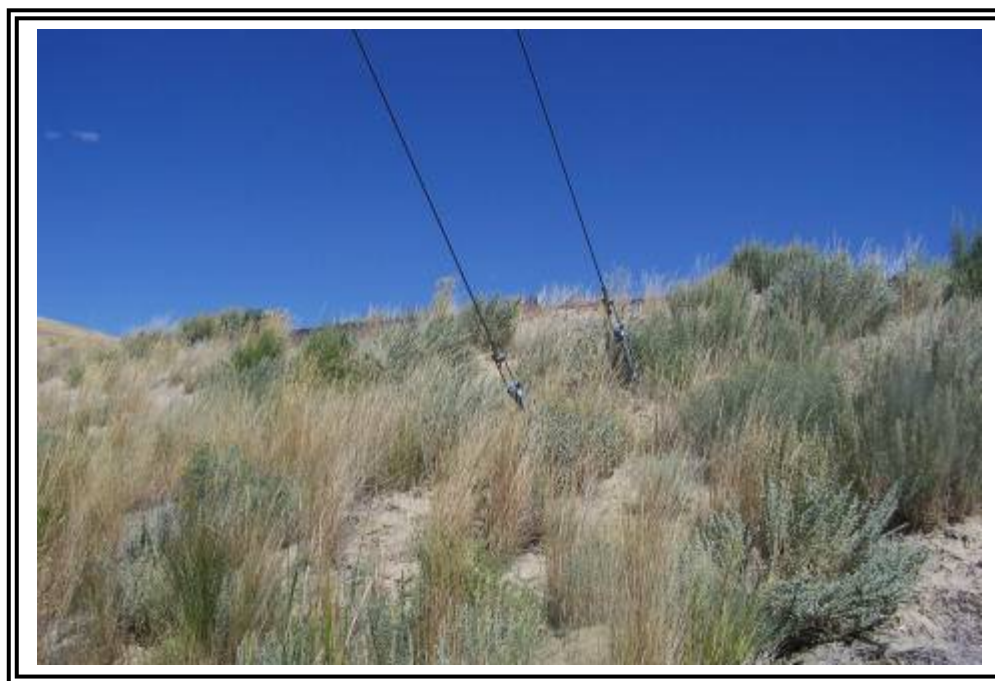
28

Guy wires from adjacent power poles at west dike downstream slope.

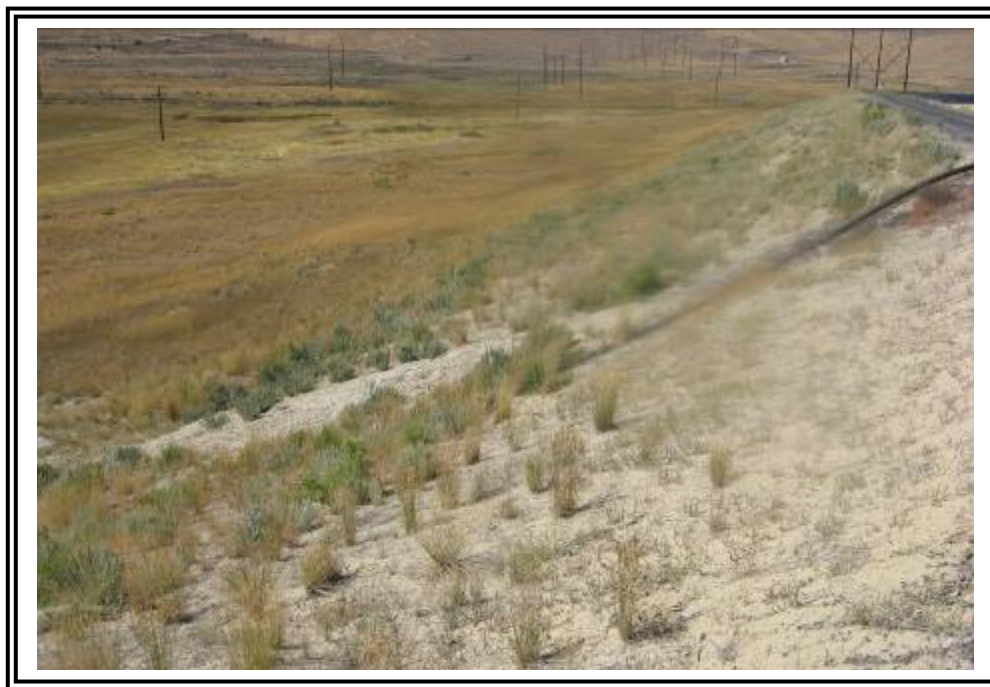
29

Sluice line and sparse vegetation mid section of southwest dike.

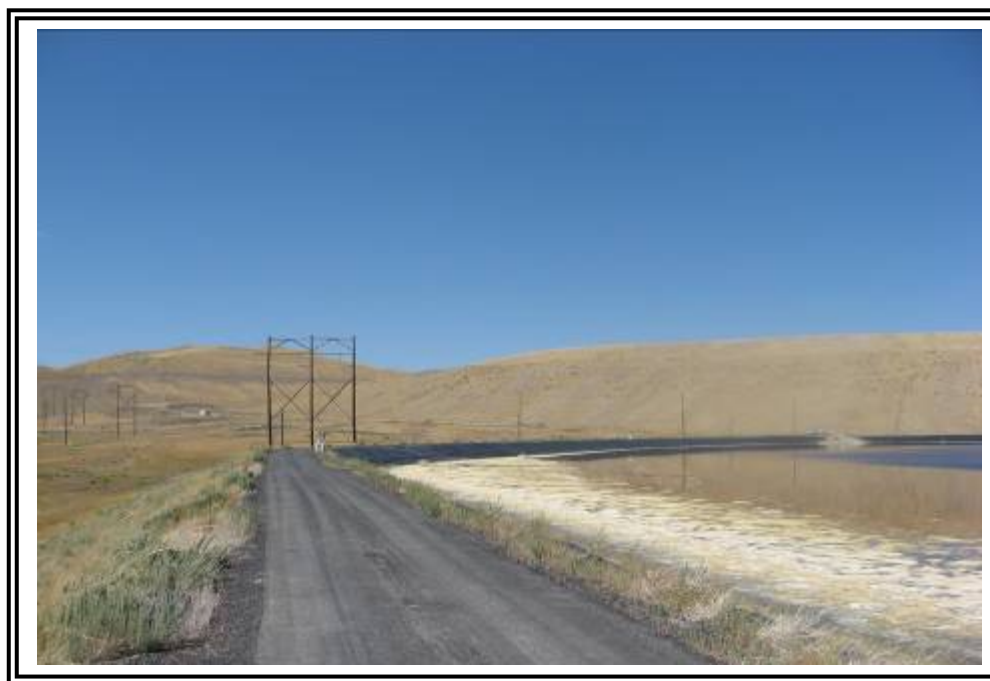
30

Crest north end of southwest dike.

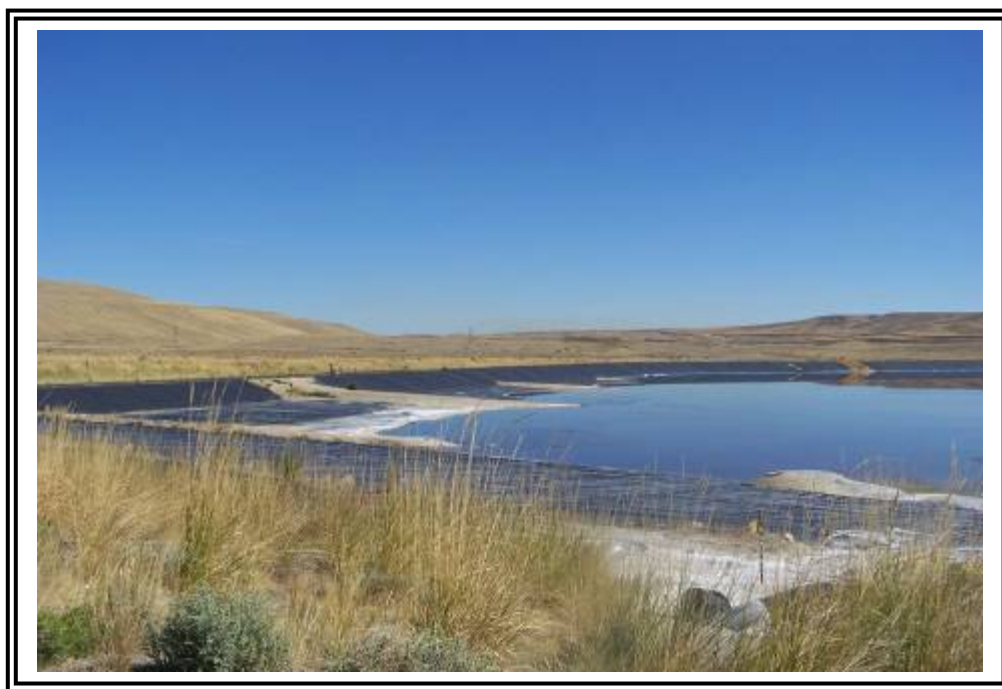
31

Northwest end of FGD #2 Pond incised into original ground.

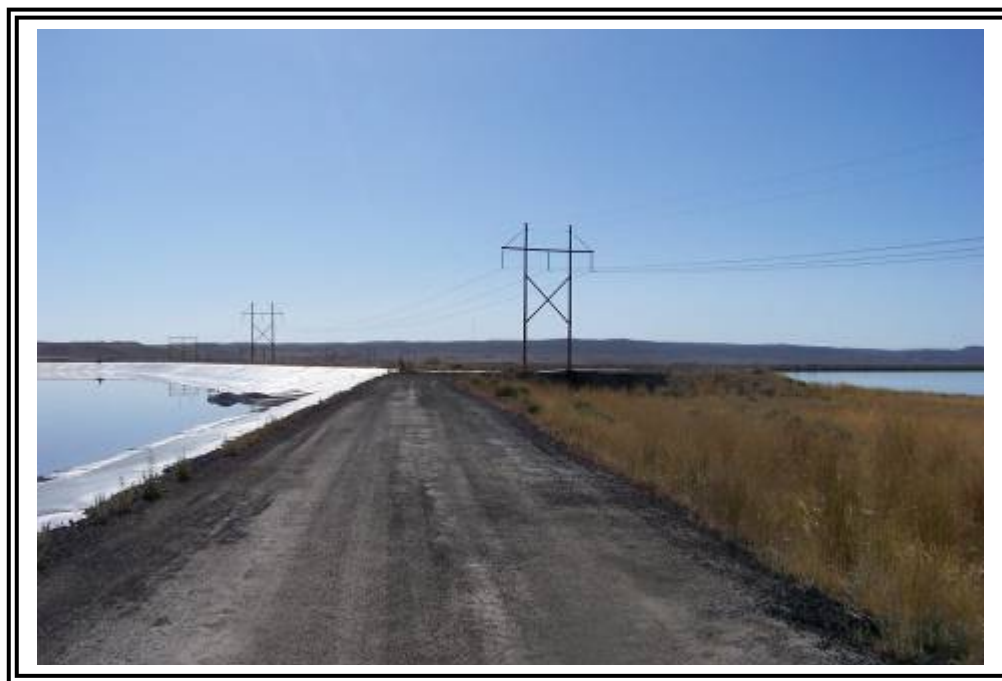
32

Southwest access road along FGD #2 Pond. Dike begins around closest Power Pole.

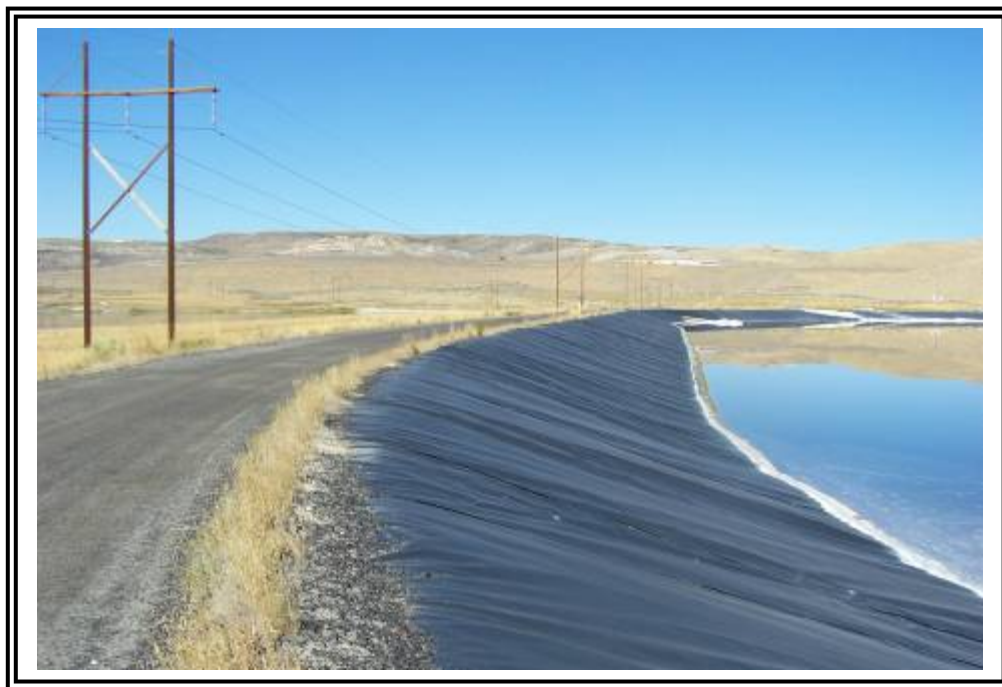
33

Upstream slope south dike looking northwest.

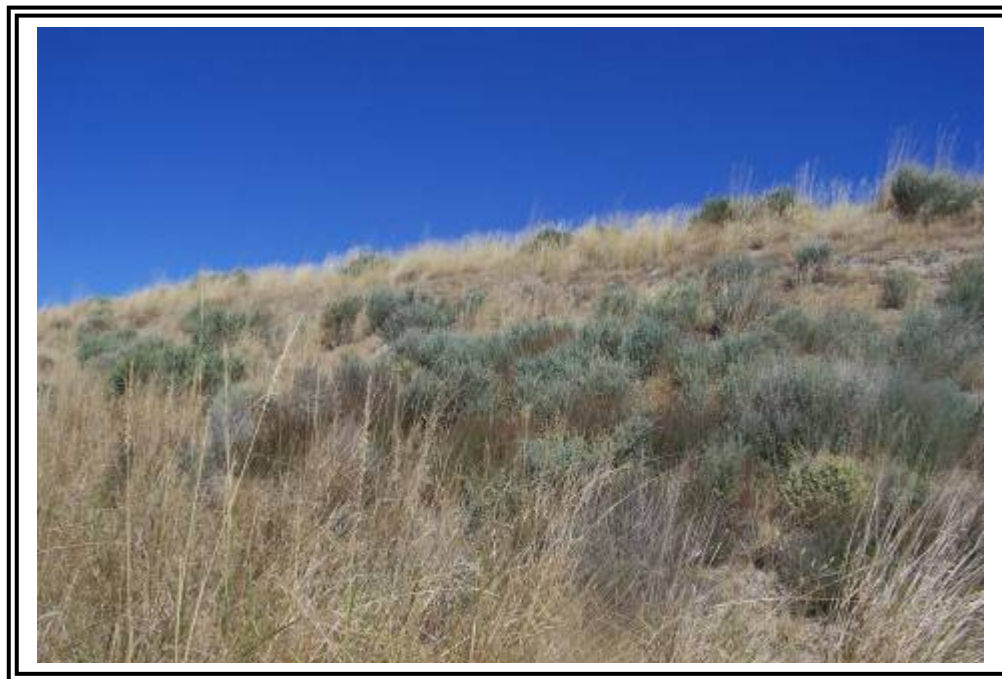
34

Downstream slope of south dike. Typical vegetation.

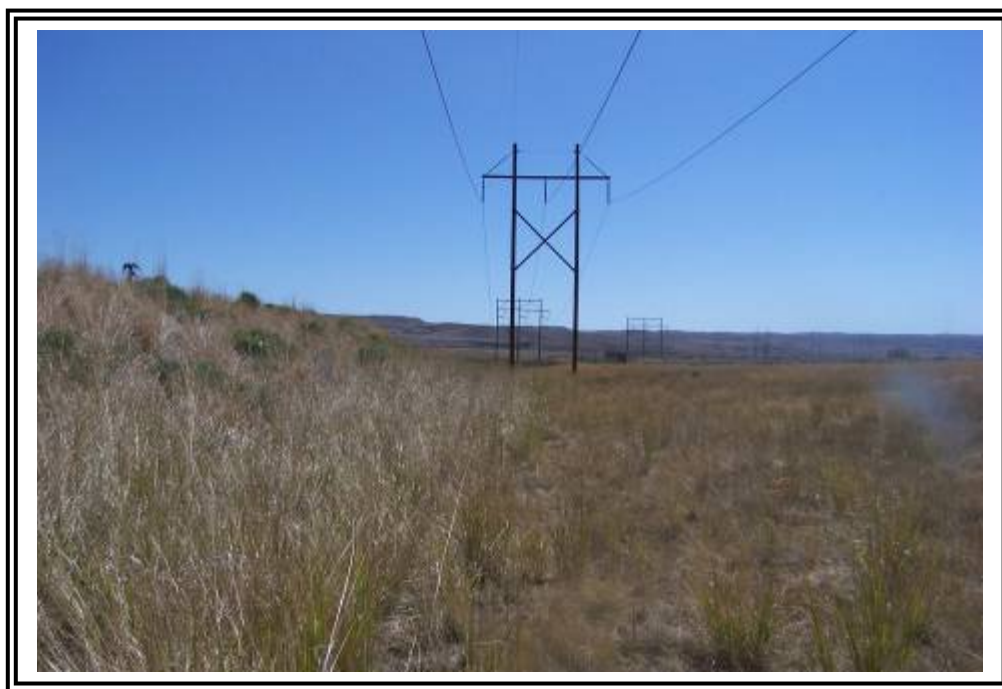
35

Downstream slope looking southeast along south dike.

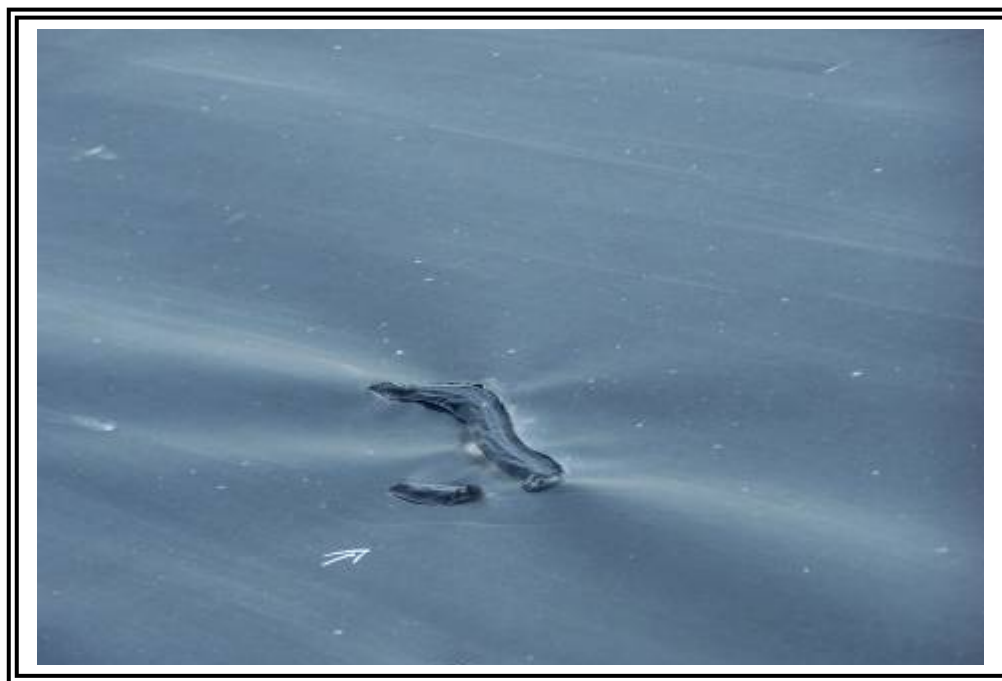
36

Patch on liner. Routine inspections/maintenance performed to correct holes generated by wildlife.

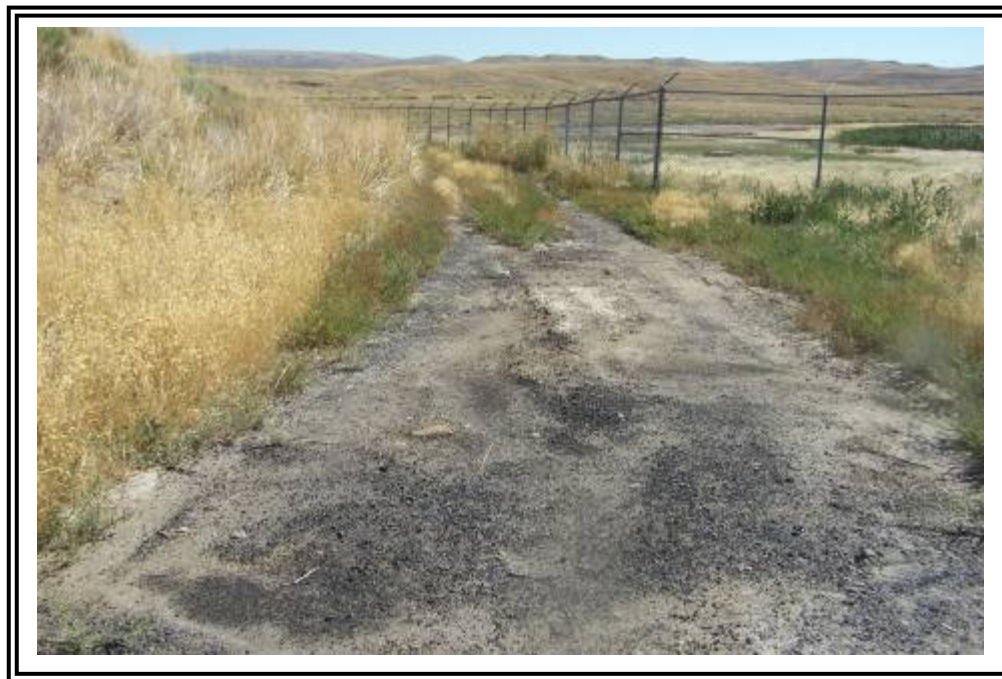
38

Access road at downstream toe at south corner looking east.
